APPENDIX B

SELECT TABLES AND FIGURES FROM PRIOR REPORTS

DATA GAP ANALYSIS REPORT

RI/FS WORK PLAN

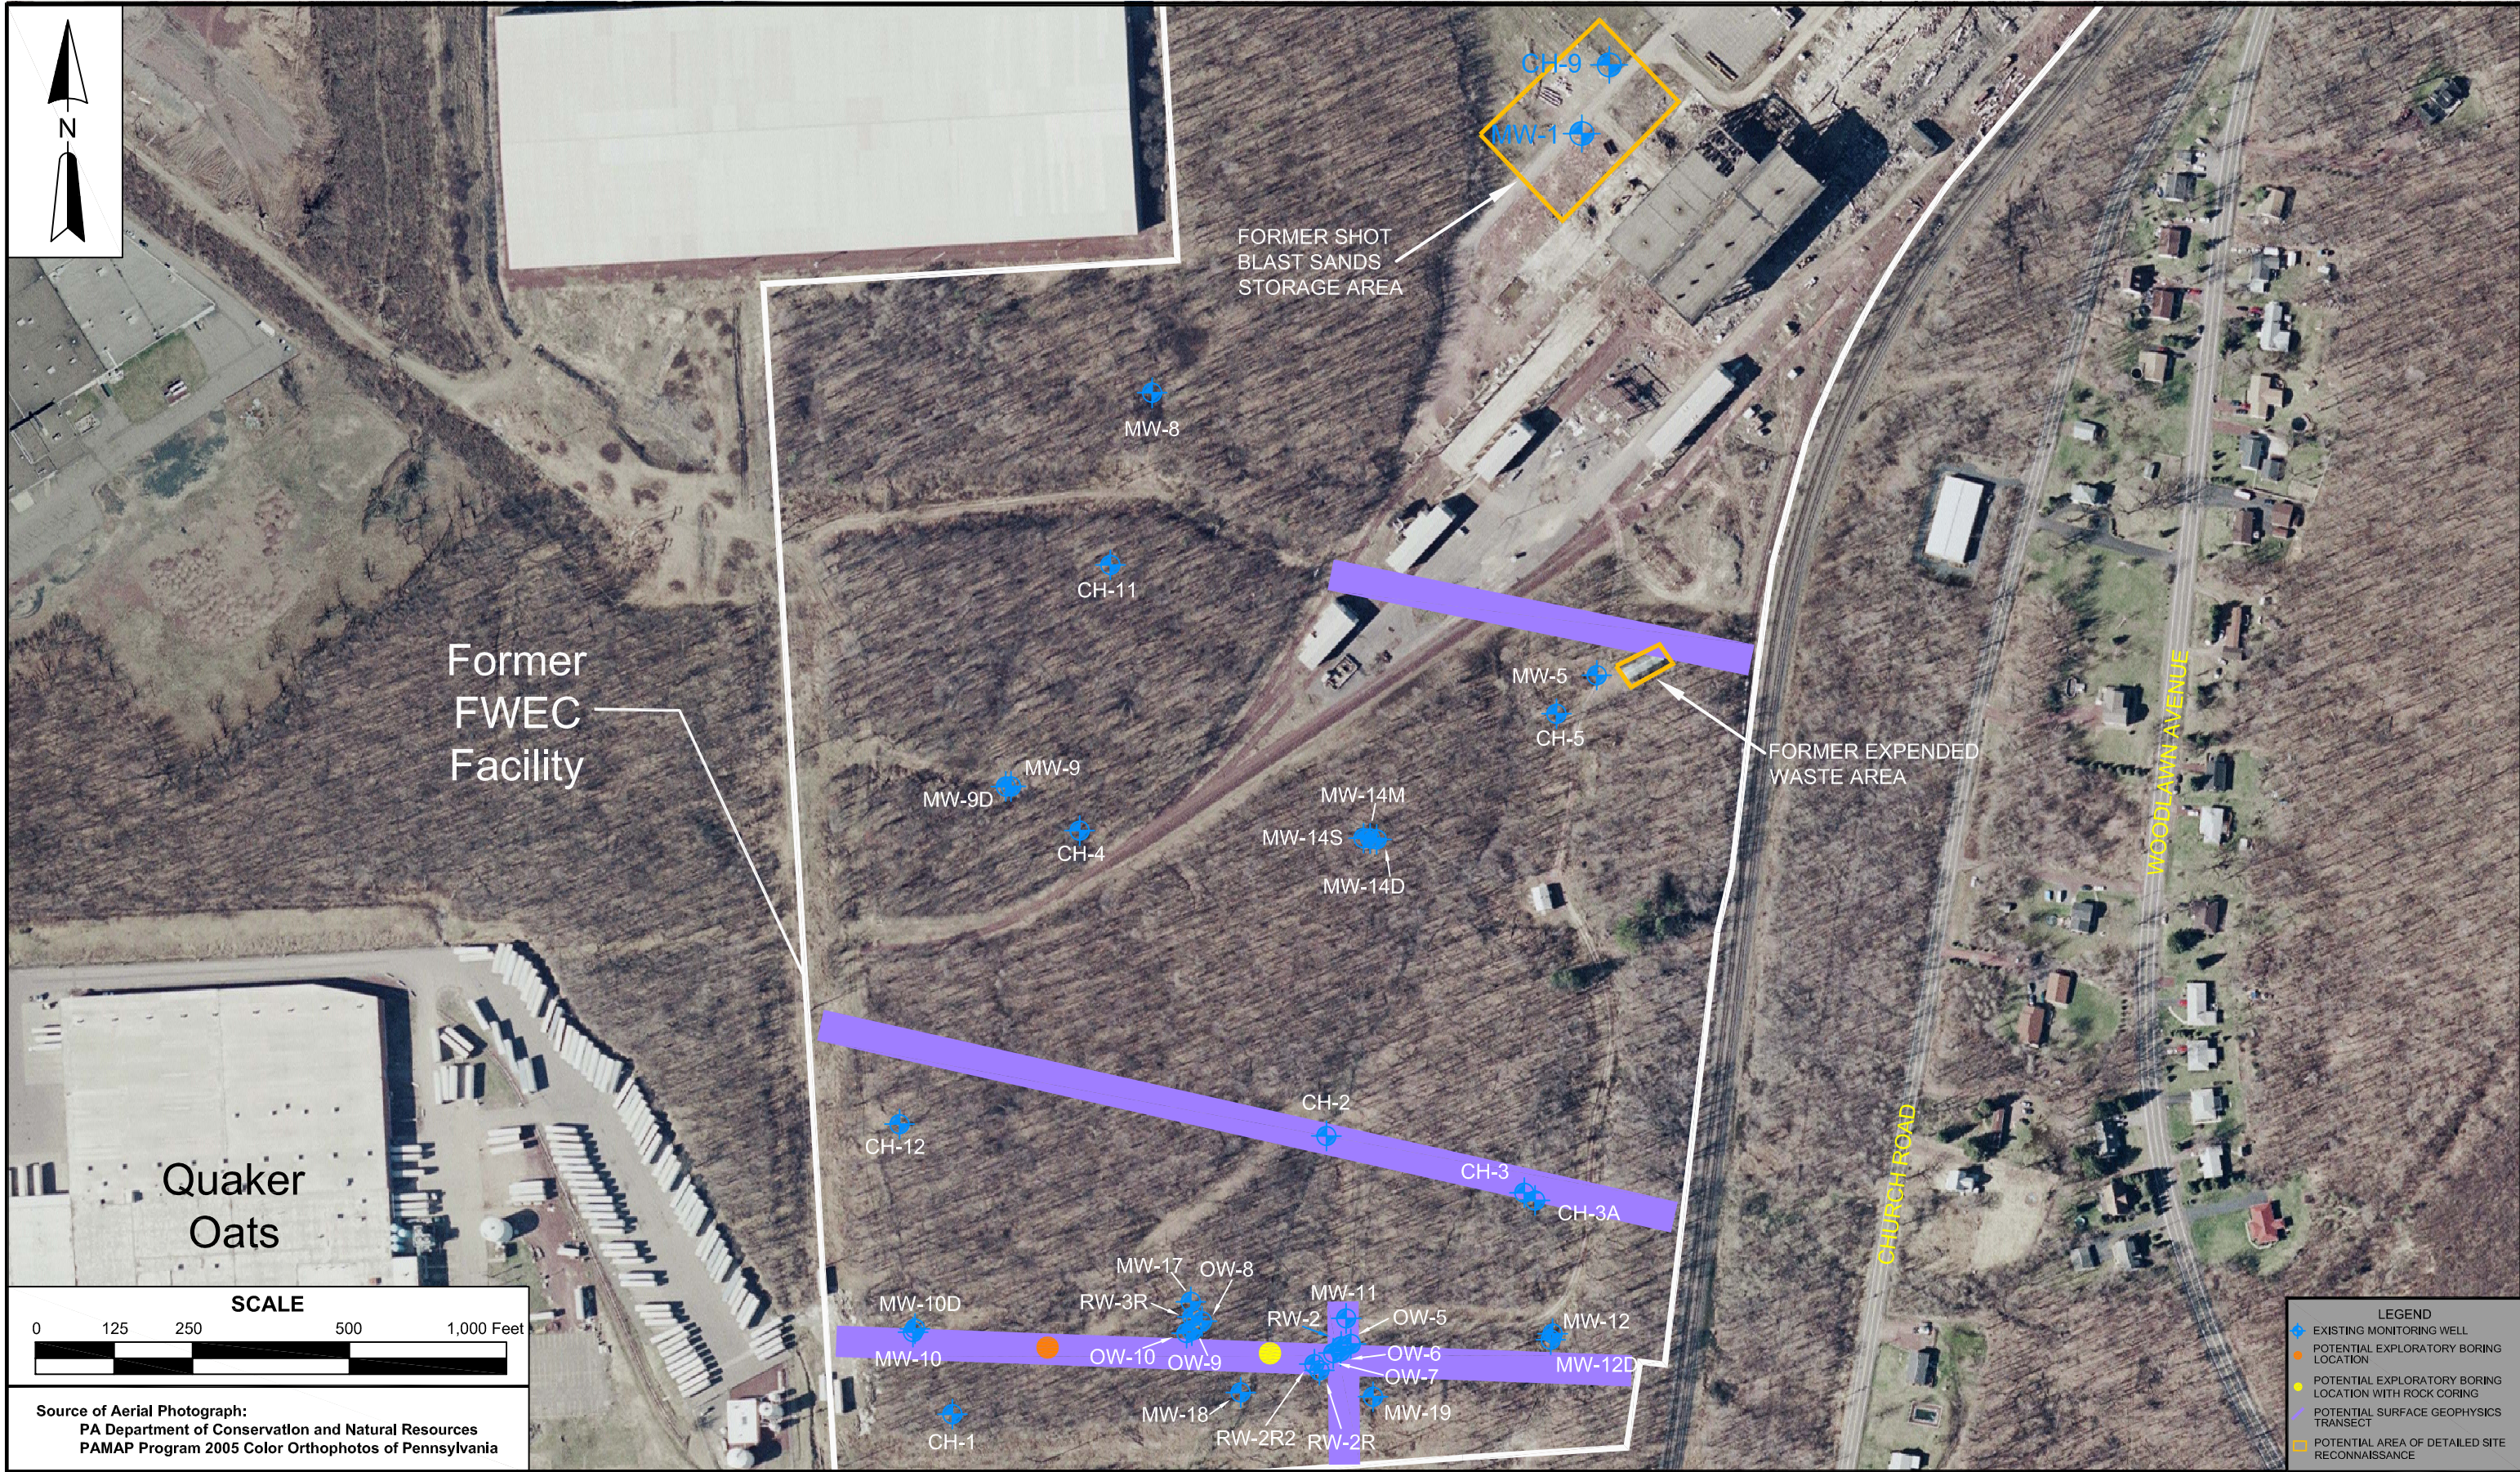
PROJECT NO.:	106-8706
FIGURE NO.:	3-1

TITLE:
Potential Exploratory Borings/Surface Geophysics Survey Transect/
Detailed Site Reconnaissance Locations – Former FWEC Facility Property
FWEC/Church Road TCE Site, Mountain Top, Pennsylvania

Potential Exploratory Borings/Surface Geophysics Survey Transect/Detailed Site
Reconnaissance Locations – Former FWEC Facility Property

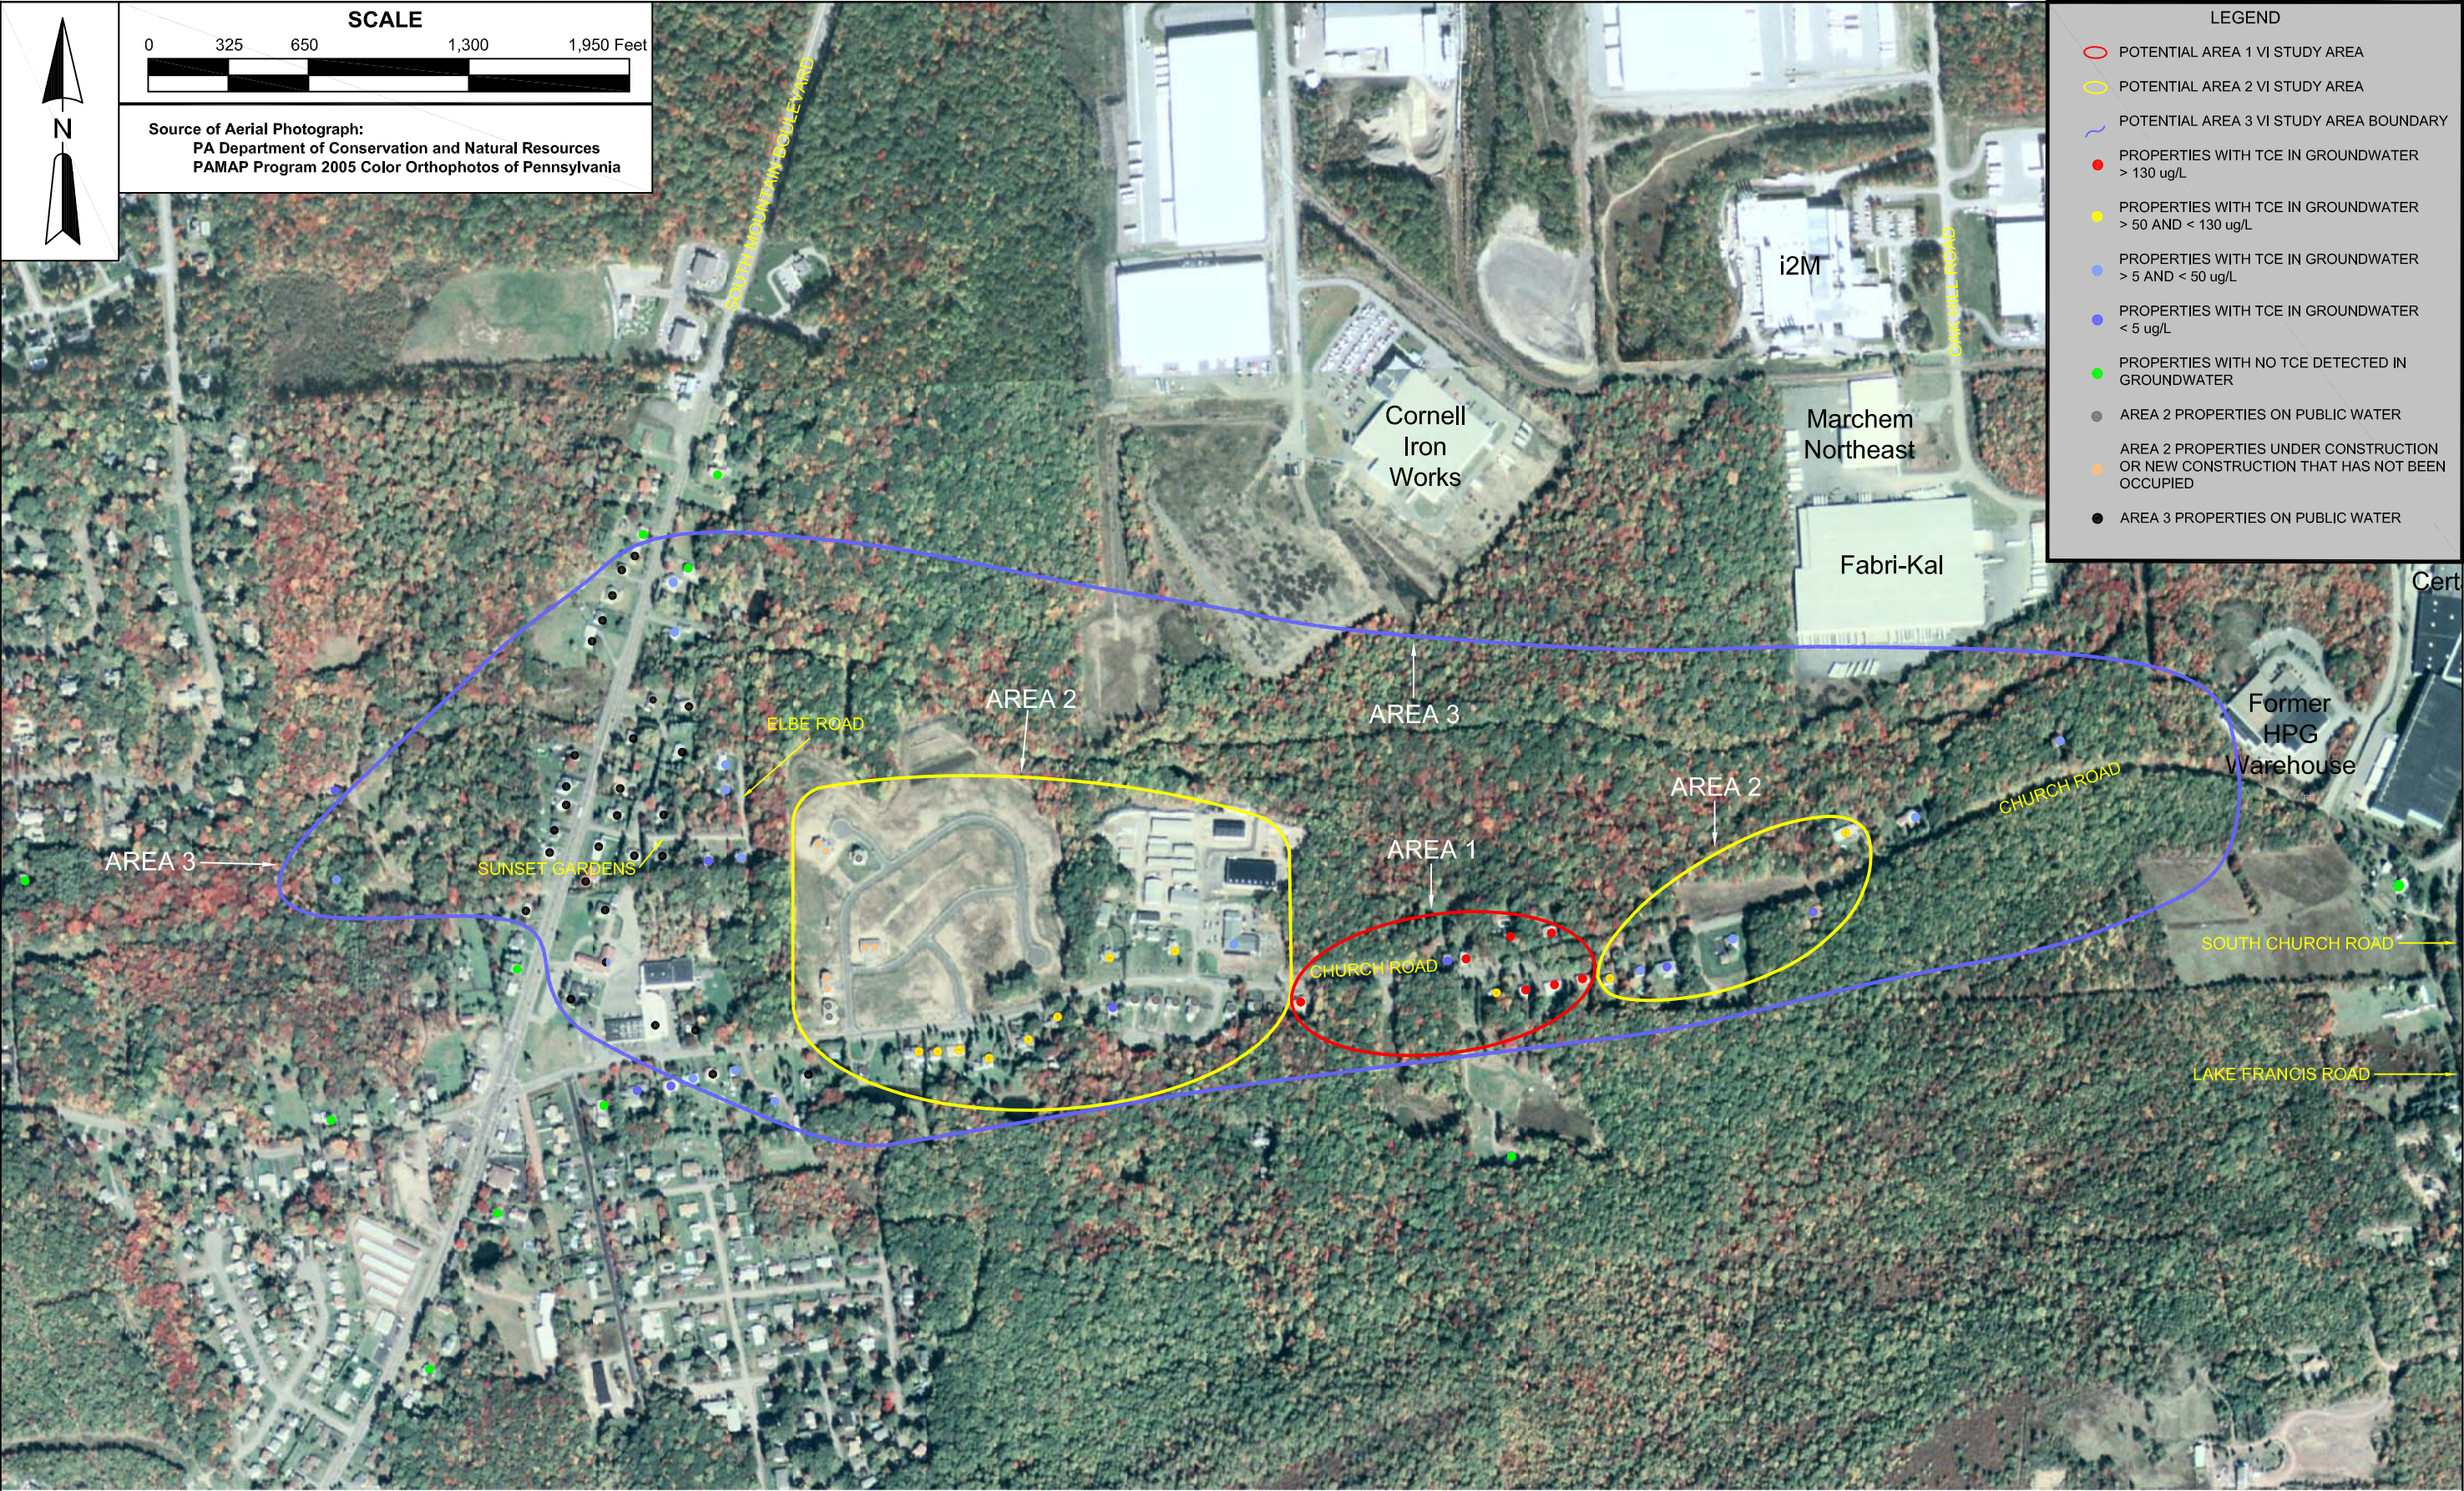
FIGURE 3-13

Potential Vapor Intrusion Evaluation Locations

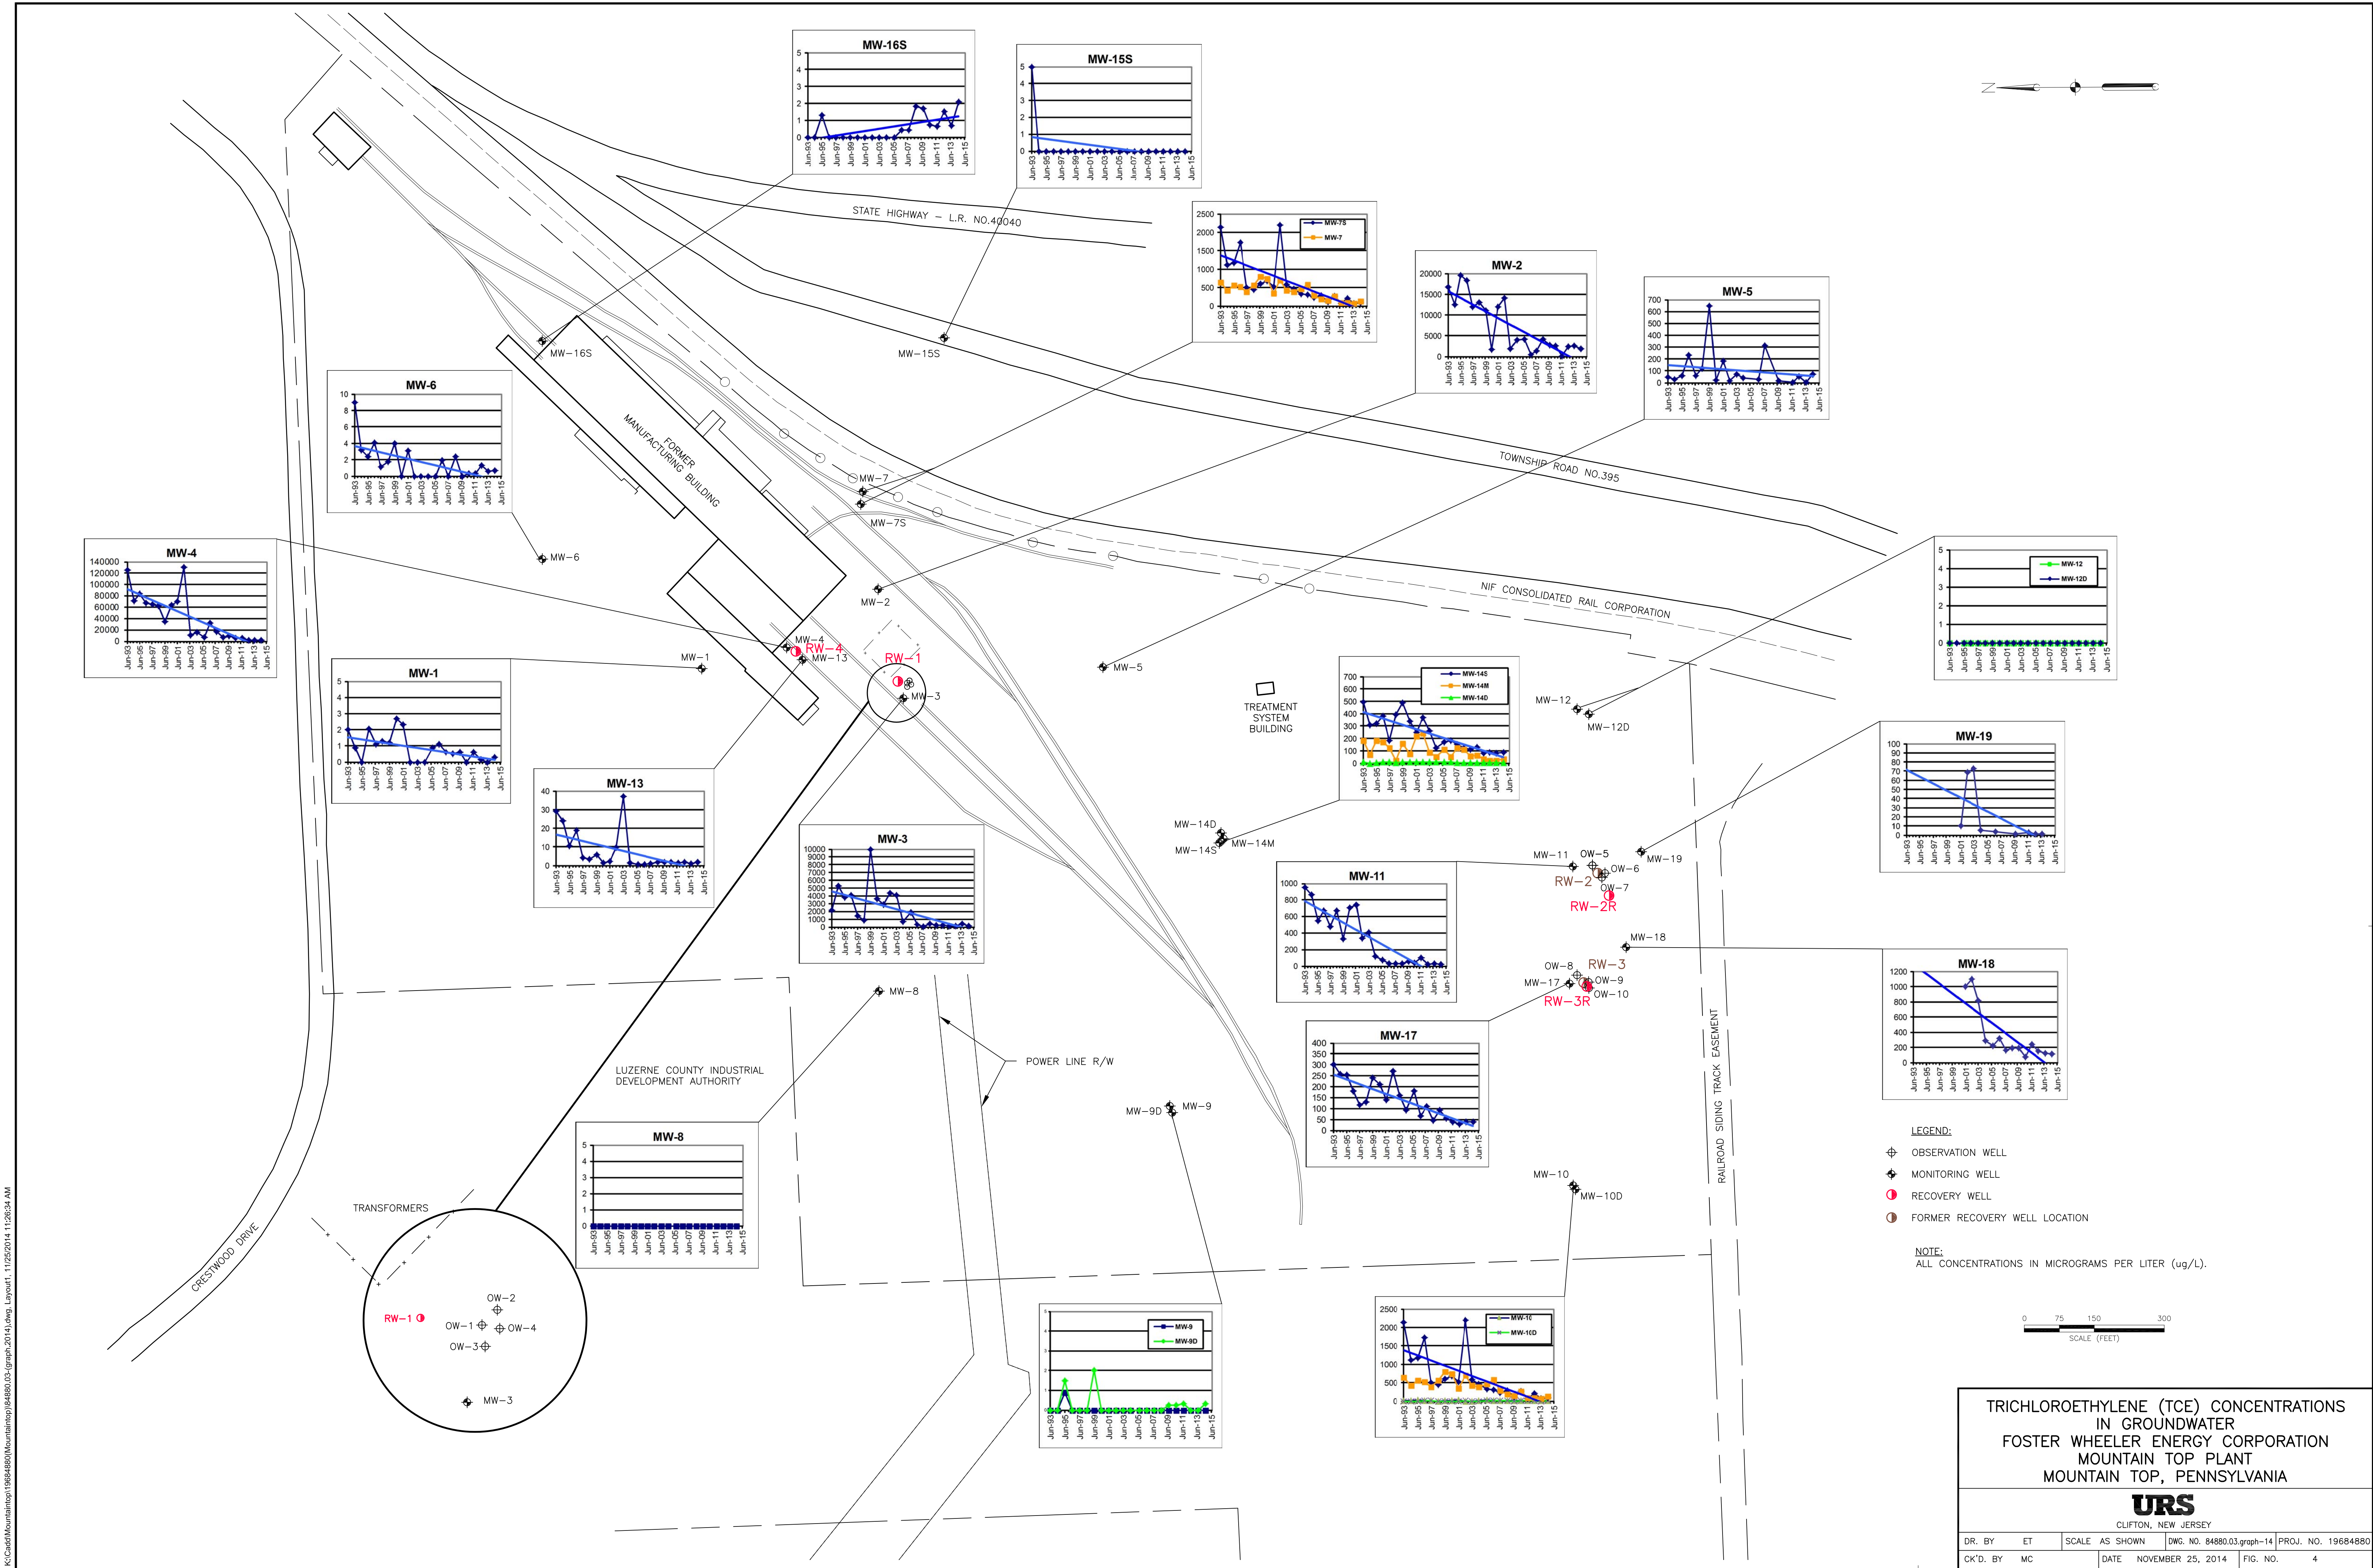
**FIGURE 4
Trichloroethylene (TCE) Concentrations in Groundwater**
